Failure Analysis of Superheater Tube

Abstract

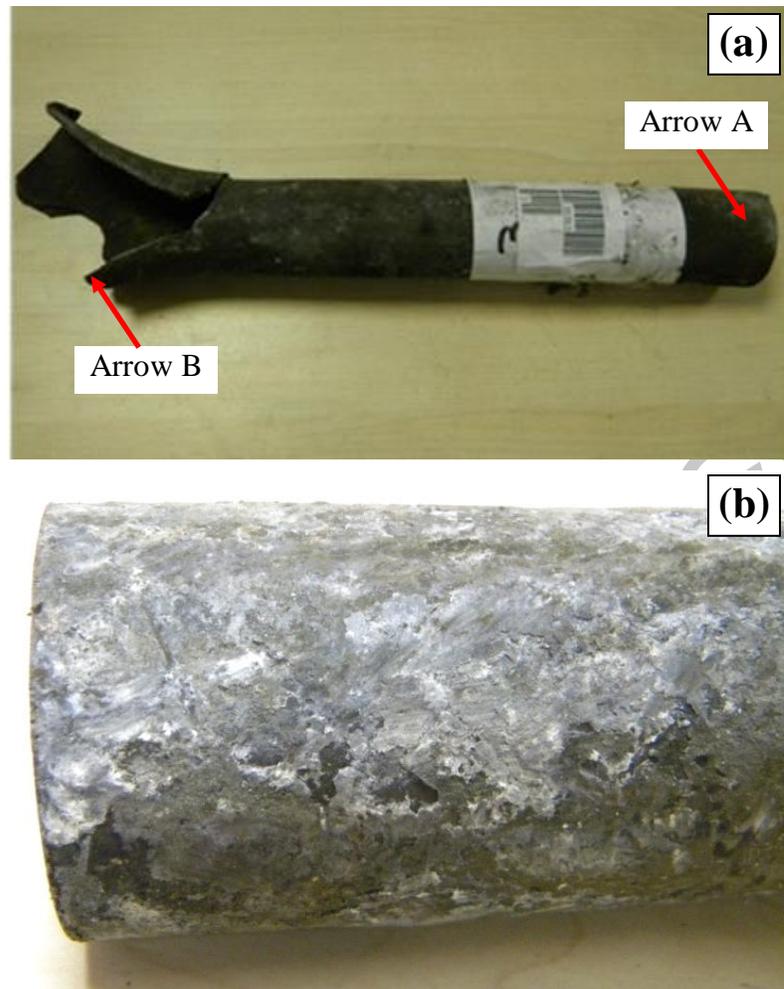
The ruptured tube shows bulging and plastic deformation at the failure site which are exhibited in Fig. 1 (a). In Fig. 1 (b), a white scale on external surface of the tube is observable. Fig. 2 shows wall thickness measurements for three sections of tubes, first transverse cross-section and longitudinal section far from failed region are shown by arrow A in Fig. 1 (a). It is seen that the tube's thickness has been reduced non-uniformly and wall thinning has been happened as can be seen in Fig. 2 (a). Also, by observing the wall thickness of longitudinal section in Fig. 2 (b), it can be understood that the non-uniformity in wall thickness has taken place from the one side (fireside) of the tube. Secondly, in Fig. 2 (c), the thickness of tube at the failed region is shown. In the failed region, a thin-lipped rupture was formed because of the swelling of the tube and significantly decreasing of the wall thickness.

Fig. 1. (a) Ruptured region of as-received superheater tube, and (b) the presence of white deposits on external surface.

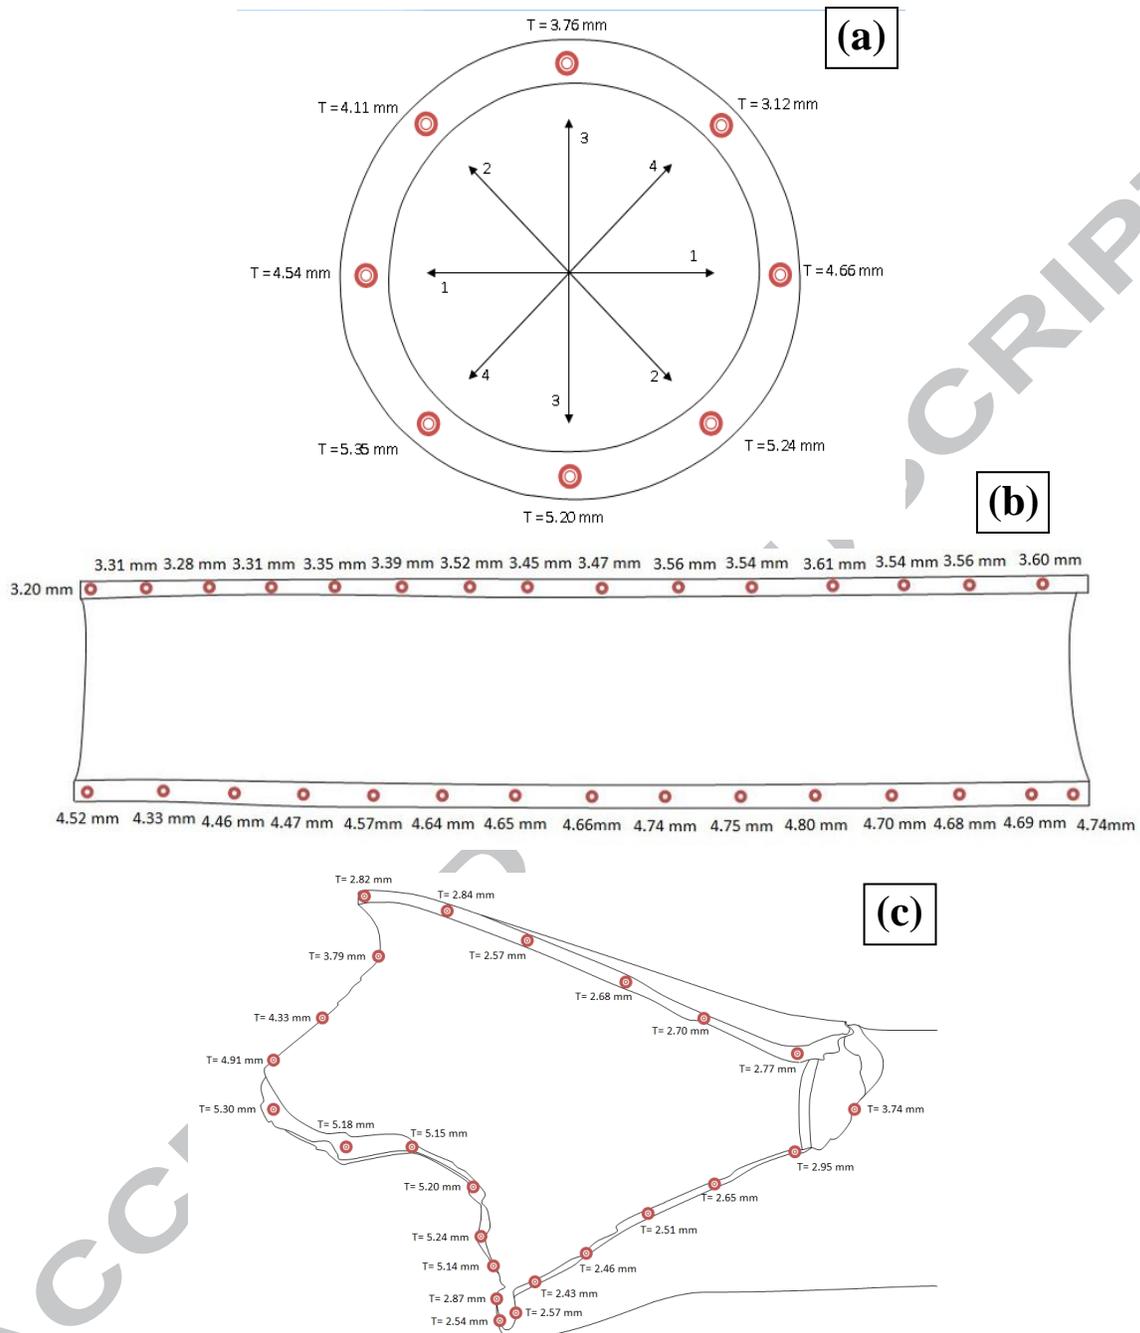
Fig. 2. Thickness measurements for two sections of tube, (a) transverse cross-section far from failed region, and (b) failed region.

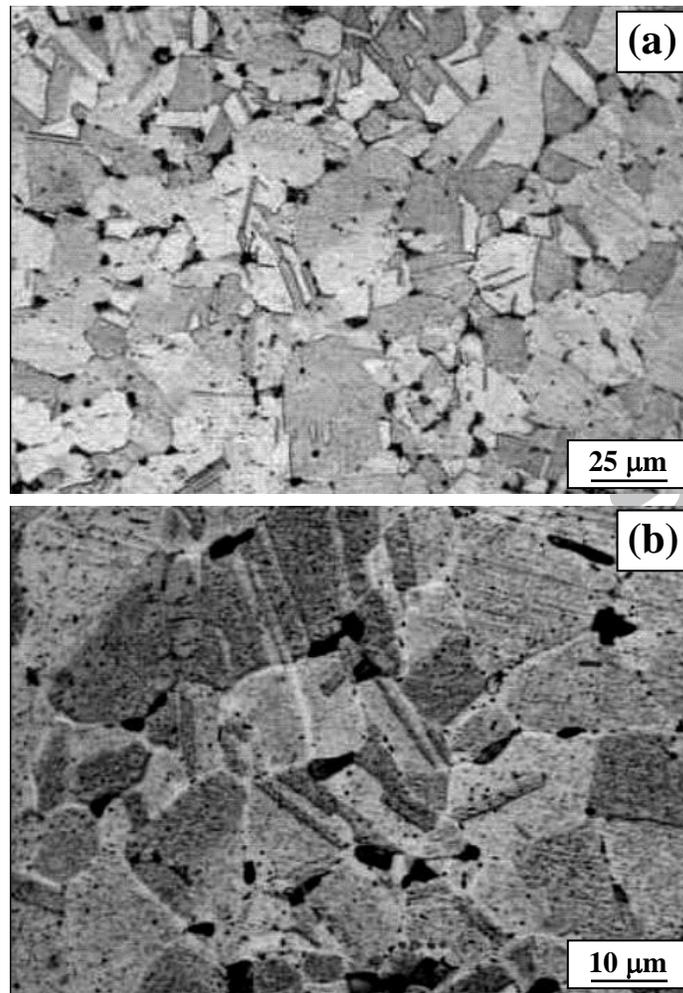
To microstructural examination, two specimens were cut away from the failed region (Sample A) and near the failed region (Sample B). Specimens were etched and microstructural observations at the mid-wall location are shown in Fig. 3 in two magnifications. The microstructure consists of austenitic grains with twinning and fine distributed $M_{23}C_6$ carbides precipitation at the grain boundaries and matrix. The presence of these phases is typical for austenitic stainless steels. However, further observation reveals the existence of new particles, which are located at the grain boundaries. The transverse cross-section SEM image at mid-wall location and corresponding EDS analysis results are shown in Fig. 4 and Fig. 5, respectively. Accordingly, the scattered niobium carbide (arrow A) and chromium rich particles, which are located at grain boundaries (arrow B) are detected. In order to observe and identify the existence of sigma-phase particles in the microstructure, a longitudinal section was cut and prepared by using electro-etch method. In Fig. 6 and Fig. 7, a SEM micrograph and corresponding EDS results are shown, respectively. As can be seen, the sigma-phase particles have been precipitated after long period of service. The existence of the sigma-phase particles can be certified by considering similar observations in literature [10]. Also, based on the EDS results, the chemical composition of these particles is close to FeCr, as a typical chemical composition of sigma-phase particles. It has been reported that the amount of sigma-phase is a function of operating time and temperature and chemical composition of material [11]. The temperature range where sigma-phase forms varies with chemical composition of metals, but in general, it can be stated that it forms at temperatures from 565 °C to 980 °C [12].

Fig. 3. Optical micrographs at mid-wall location of superheater tube far from failed region.

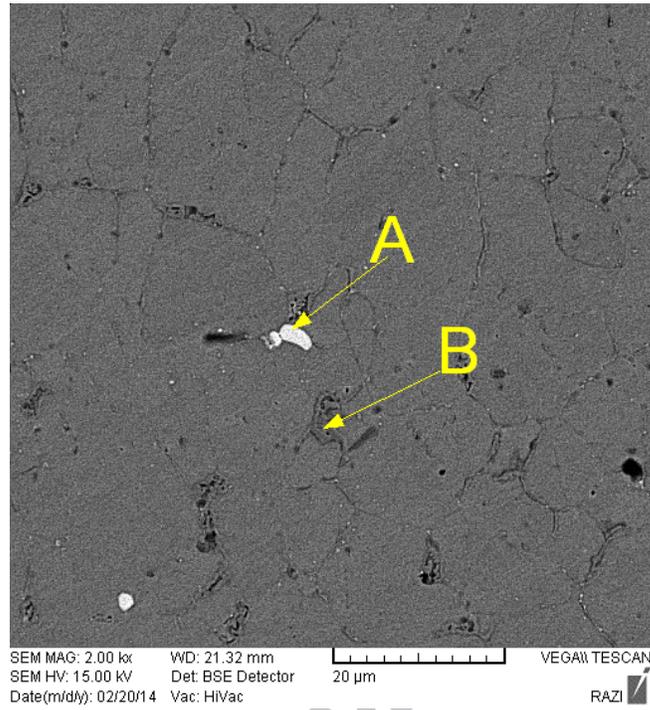
Fig. 4. SEM micrographs of transverse cross-section at mid-wall location.

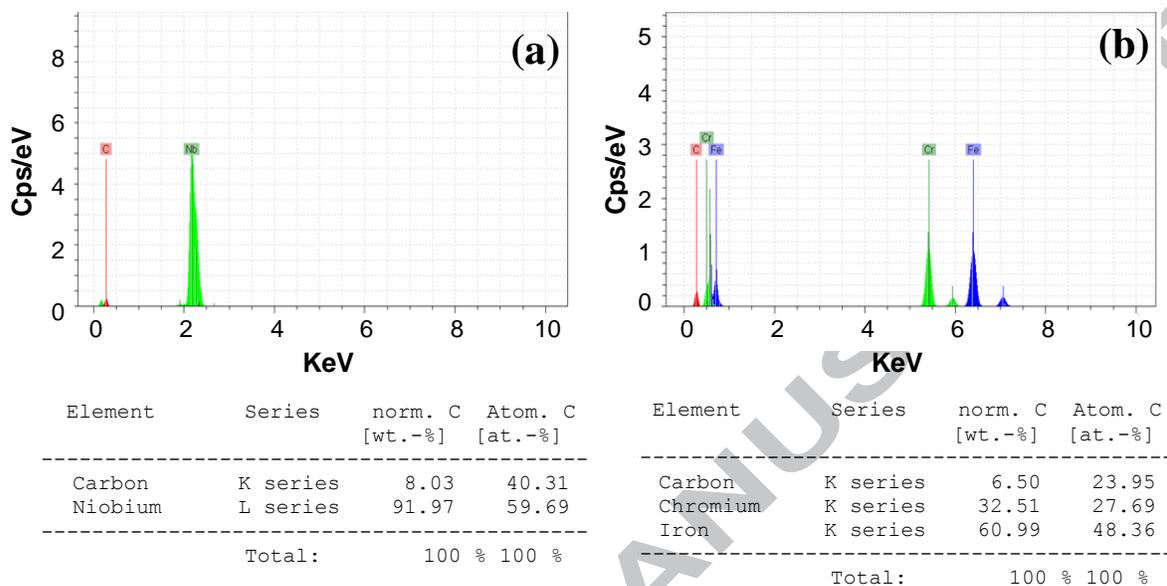
Fig. 5. Corresponding EDS results of (a) arrow (A), and (b) arrow (B) in Fig. 4.

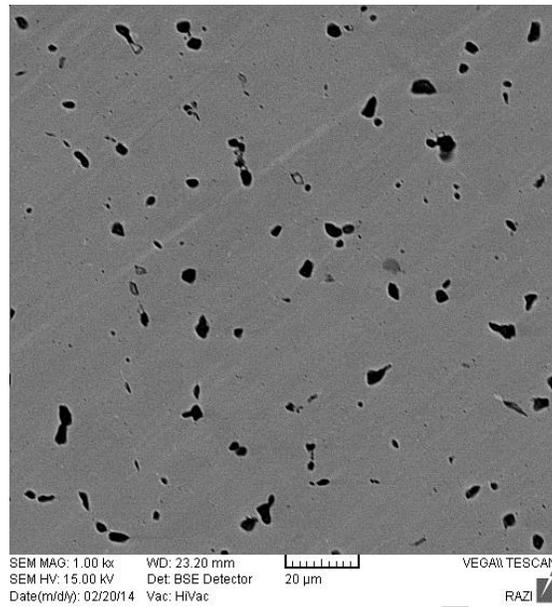
Fig. 6. SEM micrograph of longitudinal section.

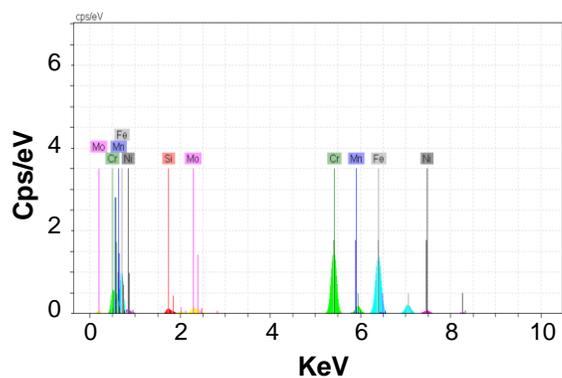
Fig. 7. Corresponding EDS results of sigma-phase particles in Fig. 6.

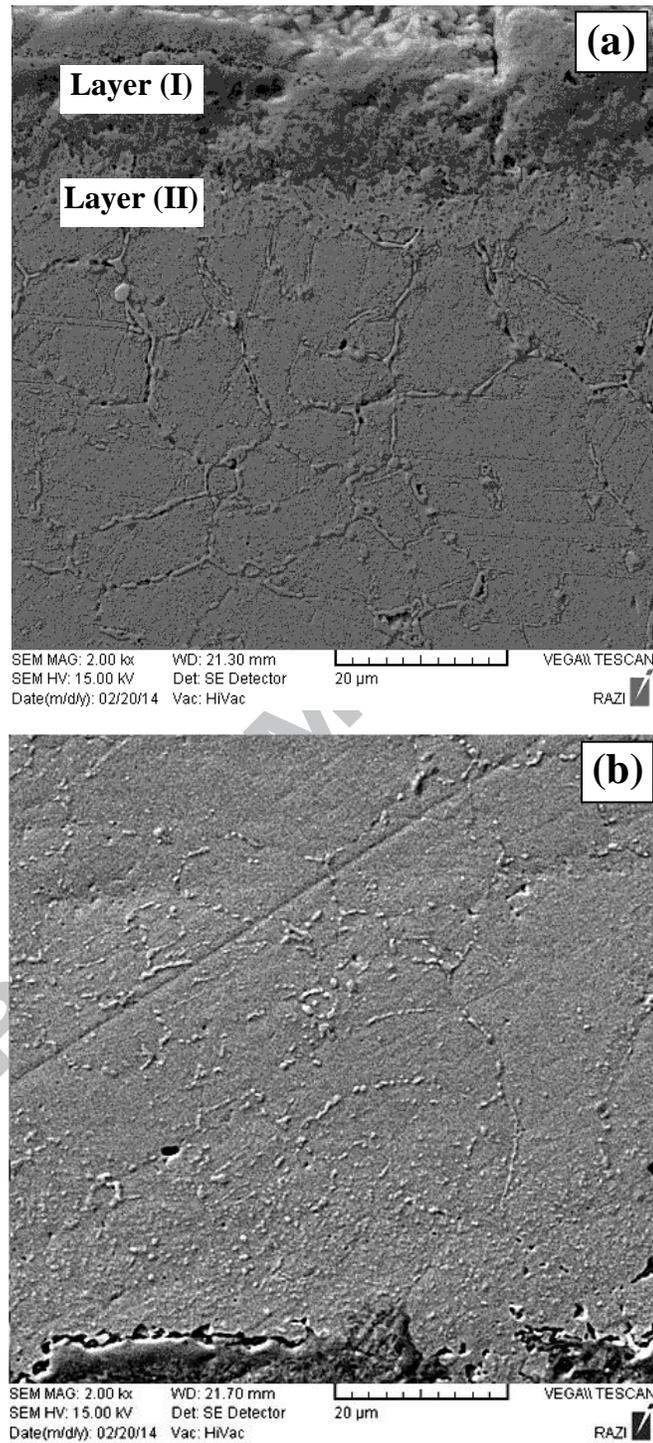
The SEM micrographs of outer and inner diameter sides of tube are shown in Fig. 8. As can be seen, a scale has been formed during the long-term service. In Fig. 8 (a), it is displayed that the external superficial scale consists of two layers. Based on the EDS analysis results, which are displayed in Fig. 9, both layers are a combination of chromic and ferrous oxidations, however, the concentration of oxygen is higher in the layer (I) and

Fig. 8. SEM micrographs at the (a) outer diameter side, and (b) inner diameter side of tube.

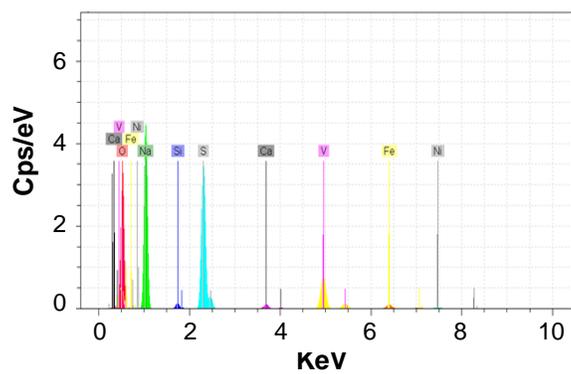
vanadium is also characterized. In order to better identification of oxides on the outer surface, the loose sheets of scales were cut and related EDS result is shown in Fig. 10. As can be seen, the substantial amount of sodium, sulfur, and vanadium has been gathered during the operation. The traces of the ash deposit are a physical consequence of the use of the fuel. In other words, the presence of these elements is related to poor and incomplete fuel combustion conditions, which has initiated hot corrosion. In this studied, Mazut has been used as a fuel for firing and Table 2 summarizes the details of its chemical composition. The main difference between the different types of Mazut is the content of sulfur. Accordingly, the used fuel is classified as a high sulfur mazut. In addition, the considerable amounts of Na and V elements present in the fuel. Here, it is worth noting to state the effect of low grade of fuel on firing. In combustion products of fuel oil, sulfur is typically present as Na_2SO_4 . At high temperature, in a typical hot corrosion reaction, molten Na_2SO_4 induced corrosion attack involves salt fluxing and sulfidation [13]. Another problematic impurity is vanadium which causes some corrosion problems due to the formation of V_2O_5 with a melting point of $690\text{ }^\circ\text{C}$ [14,15]. The situation is worsened when V-Na mixed oxides with low melting point of $550\text{ }^\circ\text{C}$ are formed during the service and make the tube vulnerable for more rapid hot corrosion [15]. These compounds with low melting point create a molten flux at service temperature ($T < 600\text{ }^\circ\text{C}$) which attacks and removes the protective oxide scale, exposing more base metals. As a result, continuous metal consumption and wall-thinning have led the tube to non-uniform wall thickness and finally to the failure. In order to support the likelihood of fireside corrosion mechanism, the ratio of average wall loss to steamside scale thickness was measured 29.5. This value is much higher than 5 which confirms the activation of fireside corrosion mechanism.

Fig. 10. EDS analysis of loose scales on the external surface of tube.

Some suggested remedies are also recommended so that to prevent or decelerate this type of failure. The first solution for preventing such failure is fuel selection. Using higher qualified fuels with lower quantities of vanadium, sulfur, and sodium will be the most important suggested remedy. Most natural and manufactured gaseous fuels are ashless, whereas most oils have ash contents. However, using of high sulfur and vanadium fuels sometimes cannot be avoided. Therefore, continuous and closed control on operating conditions is mandatory. In addition, periodic ash removal should also be considered as practical way for increasing tubes' life. Ash removal prevents development of material degradation conditions. Using fuel additives such as powdered magnesia, dolomite, and alumina is a complementary preventing method, which promotes the formation of ash deposits that are easily removed.

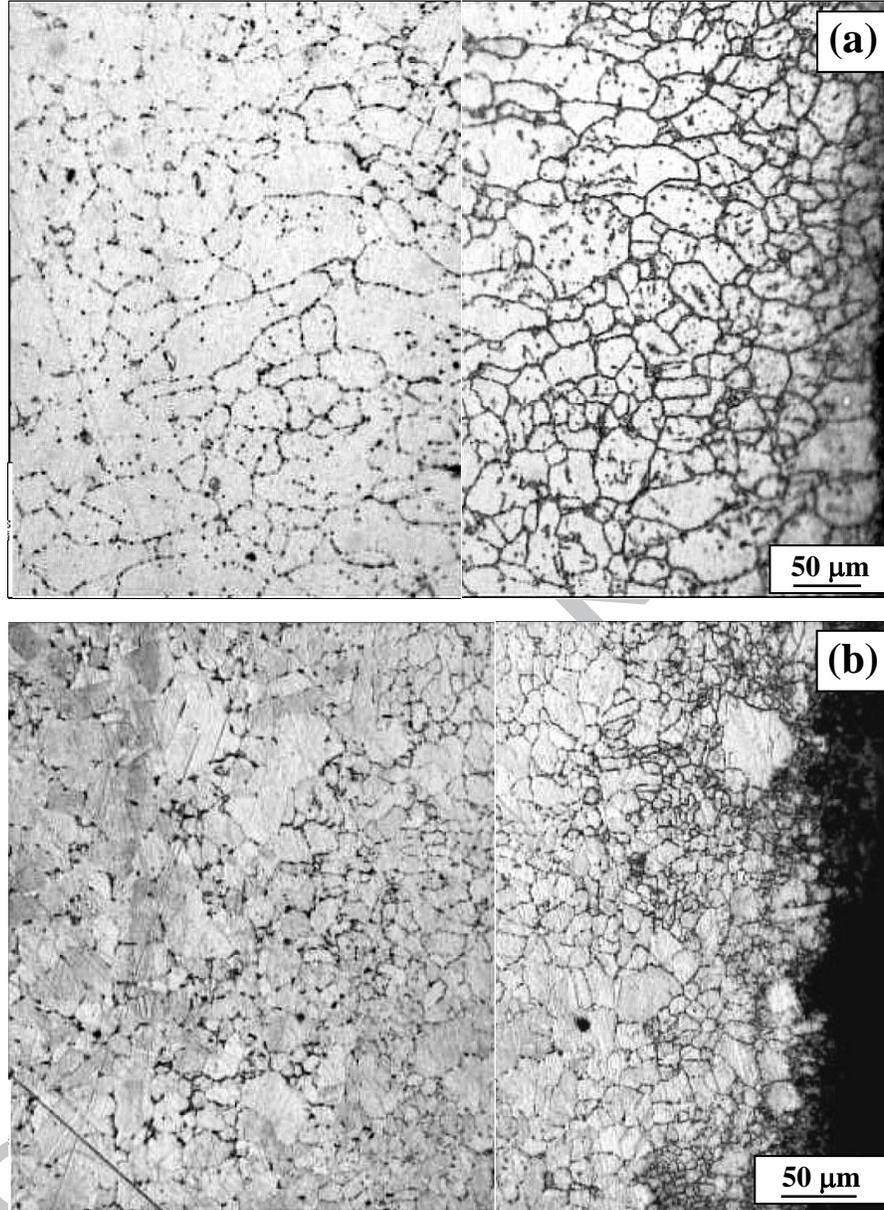
The coagulation and growth of carbides happened at both outer and inner sides of tube, which located continuously at the grain boundaries. The formation of these grain boundary carbides can somehow show the existence of high operating temperature and occurrence of overheating during the operation. In other words, the diffusion of carbon in stainless steel results in the carbides formation at high temperature. Although there was not any temperature monitoring in the power plant during the service, the growth of chromium carbides at grain boundaries can indicate the tube has been held at high temperatures due to the insolubility of chromium at these temperatures. In addition, it has been reported that the degree of carburization is governed by the levels of carbon and oxygen in the gas, the temperature and the steel composition [17]. In order to have an extensive observation, two optical micrographs are attached and shown in Fig. 11. Recent figure evidently illustrates the incremental trend of carbides coagulation near the both surfaces. Also, as can be seen, these carbides are restricted to the grain boundaries. Therefore, it is suggested that long-term overheating has aggravated the failure of tube.

Fig. 11. Optical micrographs of (a) outer diameter, and (b) inner diameter of tube in order to illustrate incremental coagulation of carbides with approaching to the tube's surfaces.

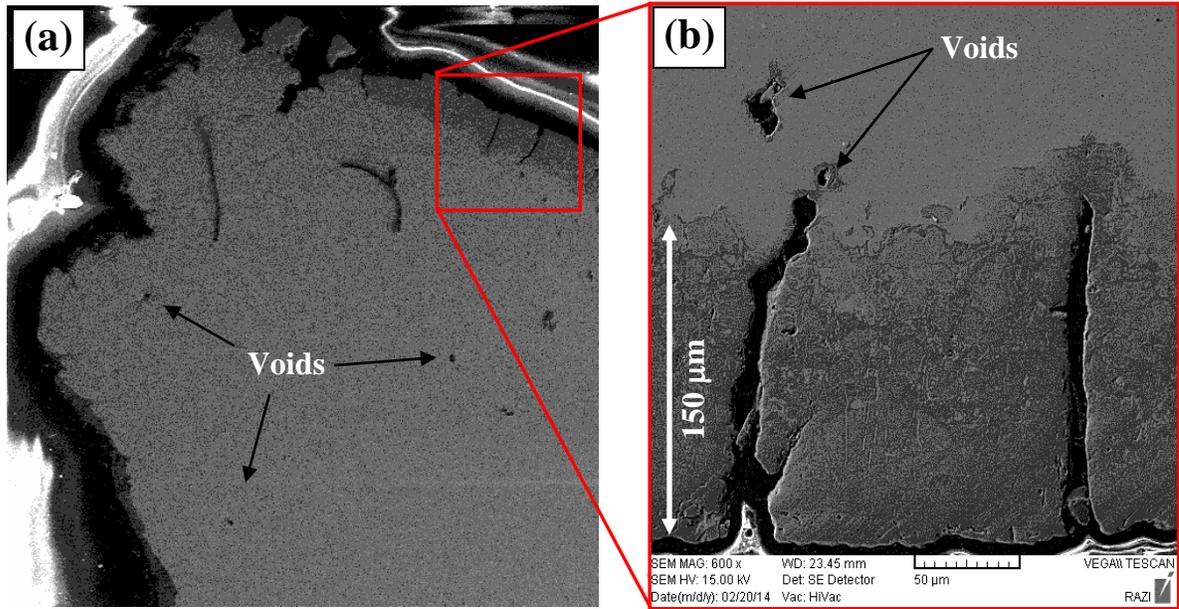
The SEM observation was also prepared from the failed region (Sample B) and shown in Fig. 12. It is seen that some microcracks present at the tip of failed region. Furthermore, some voids are appeared at the fracture lip and a very thick scale (150 μm) at the inner surface of the failed region demonstrates a severe degradation of the tube material during 20 years of operation in fireside region of tube.

Fig. 12. SEM micrographs of failed region.

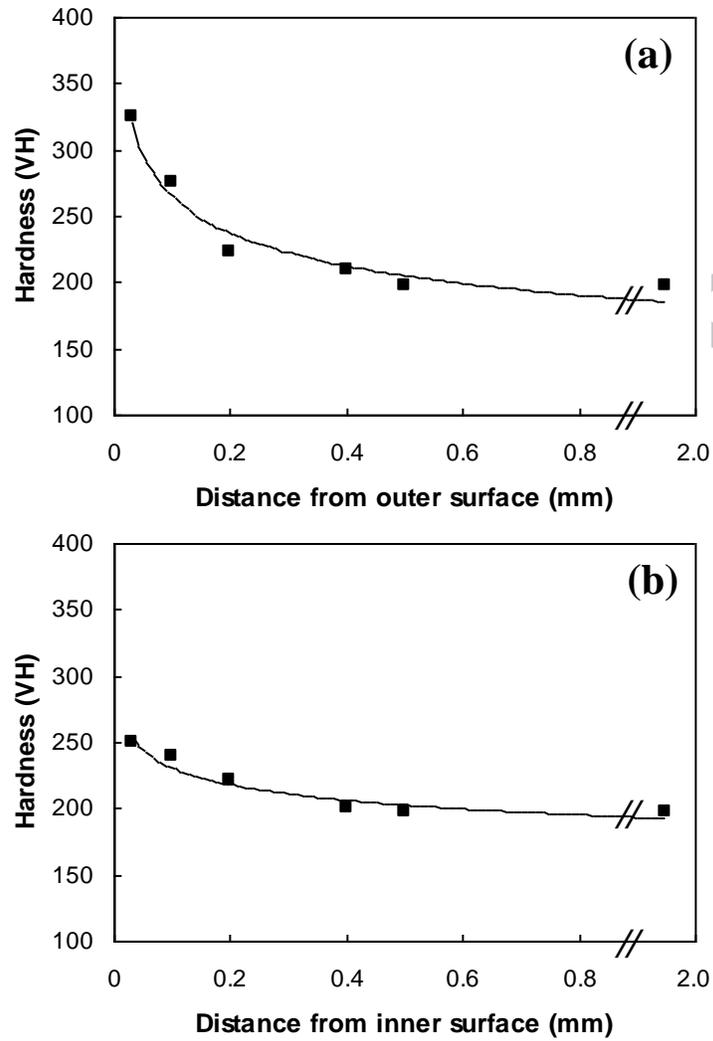
The variation of micro hardness against distance at outer and inner surfaces is depicted in Fig. 13 at locations away from the failed region. The micro-hardness test was done with respect to the ASTM E10-12 standard. As can be seen, the values of hardness decrease

after a little distance from the both surfaces and reach to a steady state at mid-wall locations; nonetheless, it decreases steeply by retreating from the outer surface. These higher values of hardness are well correlated with changes in the volume fraction of coagulated carbides at outer and inner surfaces, which were shown in Fig. 11. In the other words, these downward trends of hardness values are an evidence of carburization in tube at the both inner and outer sides. The hardness measurements have been taken at mid-walls away from the rupture section at the thin side of tube. The results of hardness at 9 points are shown in Fig. 14. It is evident that the hardness values are nearly equal at the mid-wall of the tube, which shows the activation of fireside corrosion mechanism.

Fig. 13. Variation of microhardness against distance from (a) outer surface, and (b) inner surface.

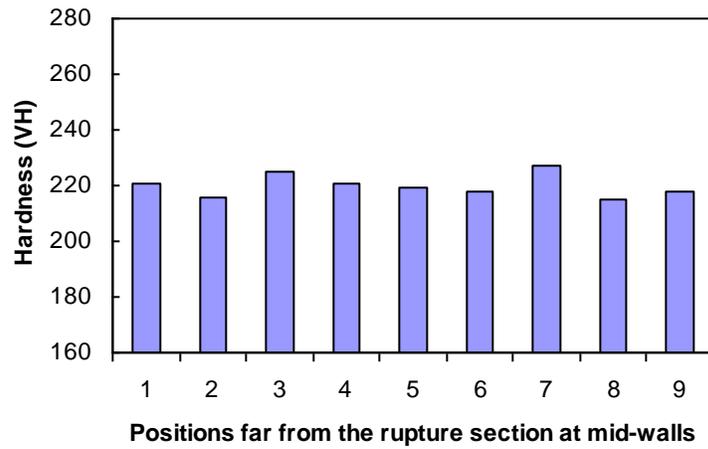
Fig. 14. The hardness measurements at some mid-walls away from the rupture section.
